SERVICE BULLETIN: JSB 016-1

Subject: J160 Family Engine Cooling

All Jabiru J160 family aircraft (All J160 & J170 models)

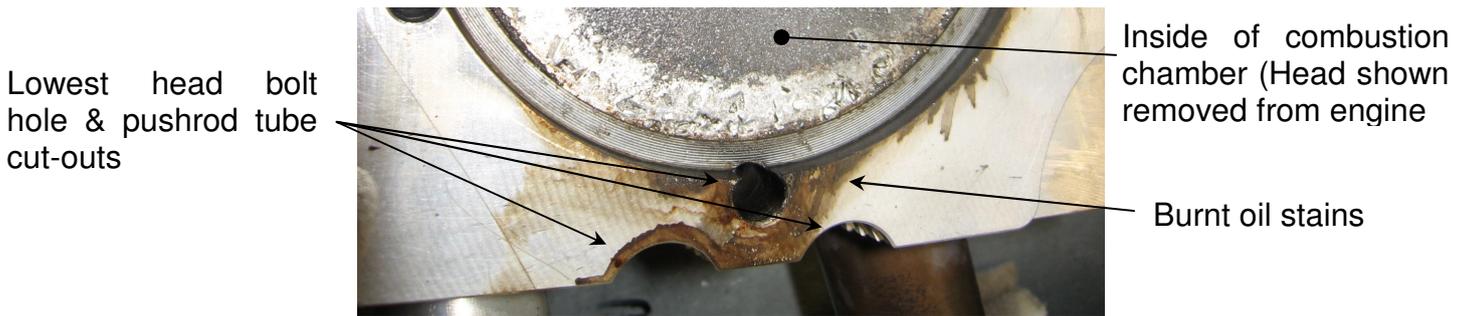
| | Score → | Never Scale Value 1 | Sometimes Scale Value 2 | Frequently Scale Value 3 |
|---|---|---|---|---|
| | Cylinder to Cylinder head seal failed (burnt oil visible on rear face of lower cylinder head fins – See Figure 1). | | ✓ | |

Figure 1 – Burnt Oil on Cylinder Head (Indicates leaking head-cylinder seal).
