## JABIRU AIRCRAFT PTY LTD

# Engineering Report: AVDALSR087-1

Subject: Procedure For Upgrading 12 Pole Alternator

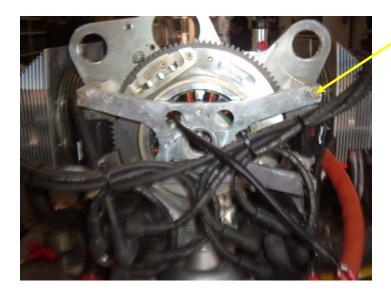
Figure 1 - Rear plate removal

Remove 4 bolts holding rear plate, gently tap off dowels, leaving spacers and ignition coils in place

- 1. A schematic showing the current and altered wiring is shown in Figure 7.
- 2. Disconnect the battery before you commence any work.
- 3. Disconnect stator wiring terminals and harness wire ties, then remove retaining bolts holding the rear plate and stator assembly from the engine, as shown in Figure 1.

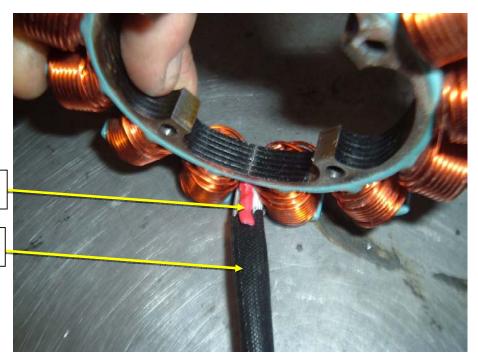
Figure 6 - Harness location

Soldered and heat-shrunk connected wire pair (red)

Insulated wire pair to regulator

Insert the other 2 wires, one into each lead terminal and re-solder. Slide the white and black insulation back down over the soldered terminals and fold down between the coils over the previously joined pair of wires, as shown in Fig 6

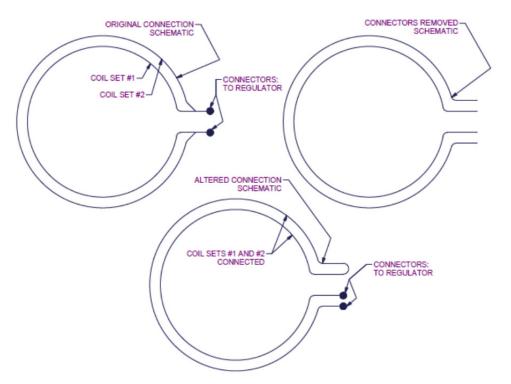
Figure 7 - Wiring Schematics

At manufacture, the 12 pole stator assembly was wound with 2 circuits in parallel. This reduces the effective length of the windings, limiting the output at low engine RPM. By re-connecting the wound coils on the stator in series, the effective length of the windings are increased, with a corresponding increase to the output voltage. The procedure given below details how the change may be carried out to engines in service.
